Blue Lake Springs Mutual Water Company

# WATER SYSTEM IMPROVEMENT USDA PRELIMINARY ENGINEERING REPORT FINAL

**November, 2016**

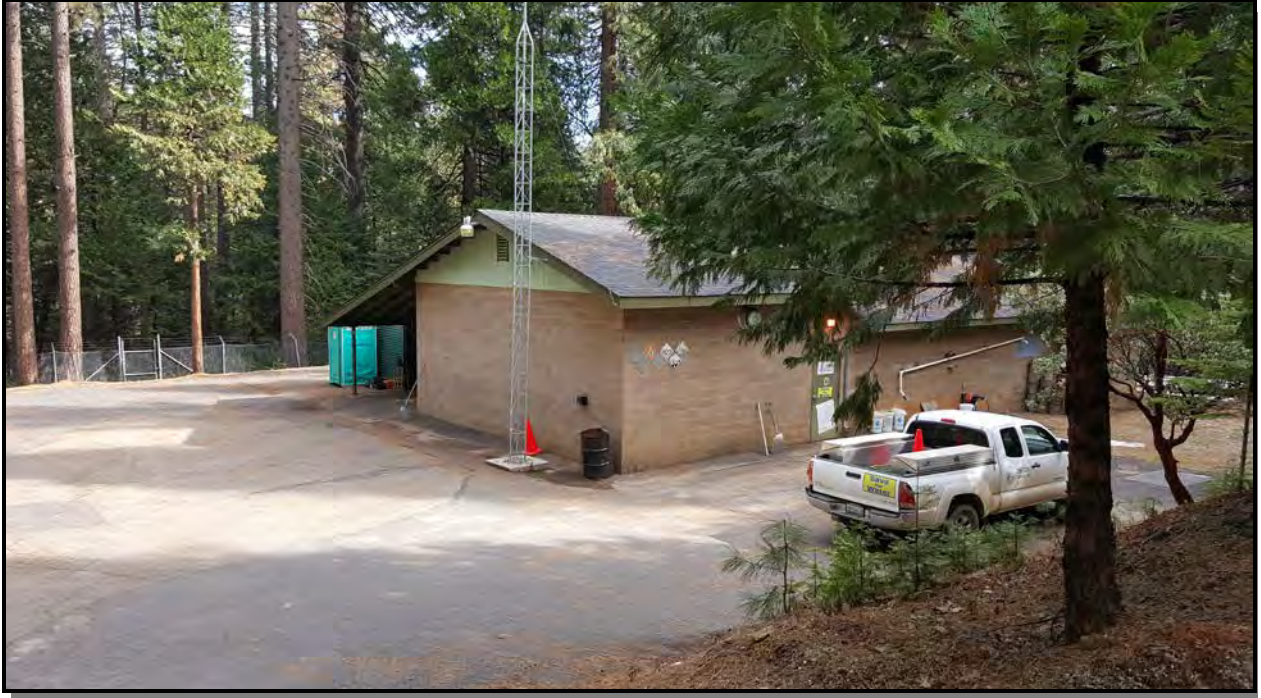
**Figure 2.4.2a**  
BLSMWC Water Treatment Plant

Three remote telemetry/SCADA links control processes at the water treatment plant, the booster stations, and the well system. The water treatment plant and Clearwell is located at 491 Blue Lake Springs Drive (**Figures 2.4.2a and 2.4.2b, below**)

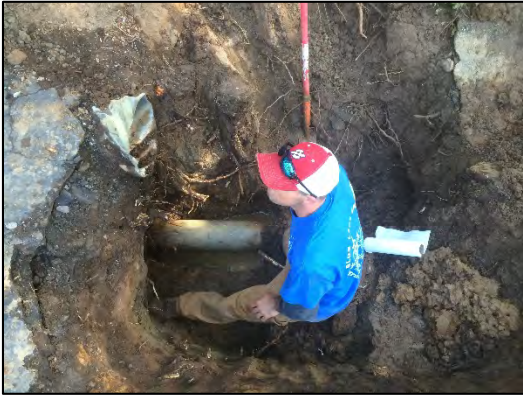
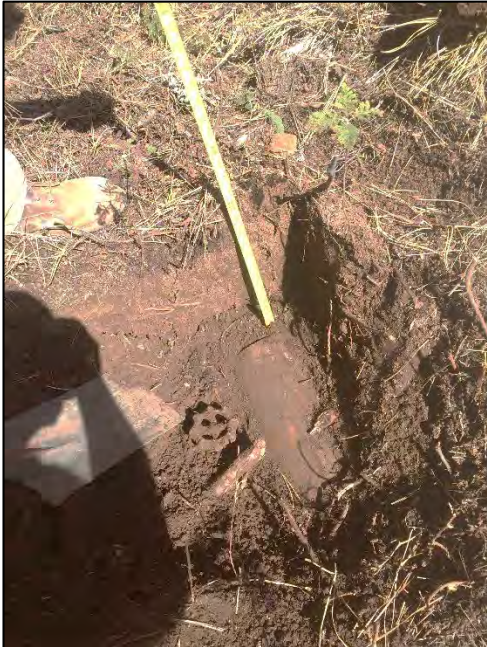
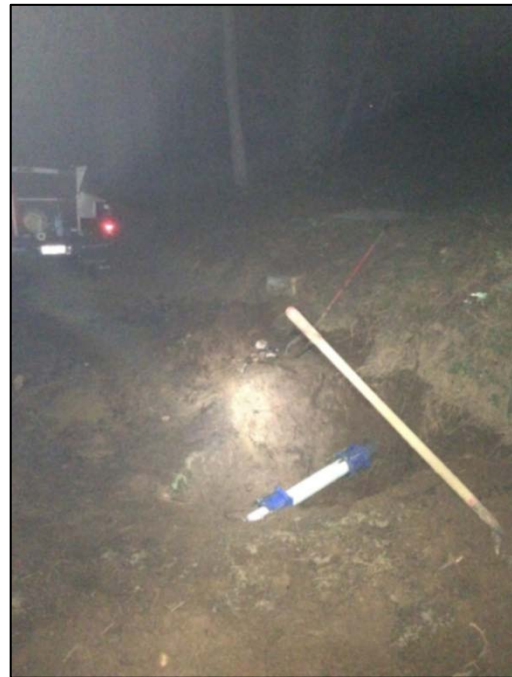
**Table 2.4.4a**  
Water Distribution Deficiency (Photos)

Also included are various photographs of distribution deficiencies (**Figure 2.4.4a**)

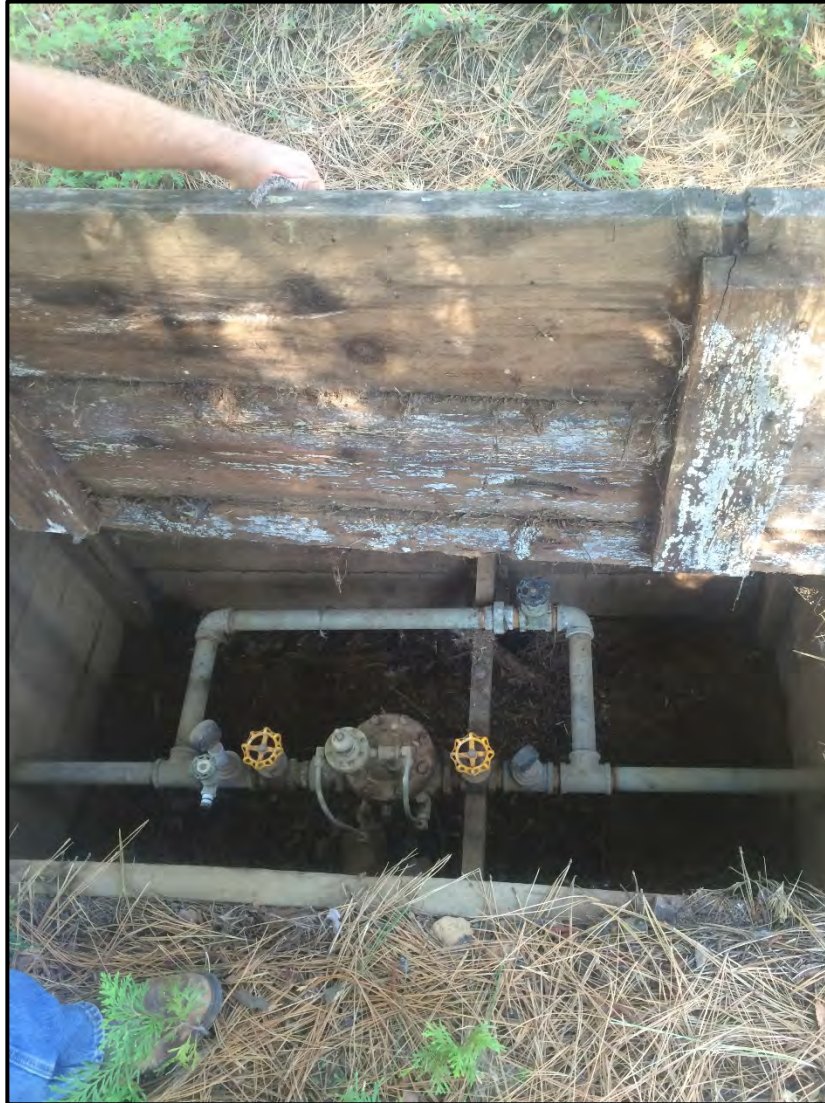
**Figure 2.4.5a**  
Deteriorated PRV Station Located on Dorothy Drive

Below (Figure 2.4.5a) is a photograph of an old and deteriorated PRV that needs to be replaced.

The PRV Station consists of installing five (5) new 6-inch and one (1) new 1.5-inch PRVs throughout the service area (**Figure 6.1**). The new relocated PRV stations will require a cut-in to the existing main, vault with traffic rated cover/lid, and pressure reducing valve and appurtenances. The vaults will require double access doors to meet CA OSHA requirements with additional details to be developed at the 10% design stage. A preliminary cost-estimate for the PRV station project is shown in **Section 4**, above. A typical detail for a PRV is noted below in **Figure 6.1.2a**. **The PRV station improvements are estimated to be \$160,000.**

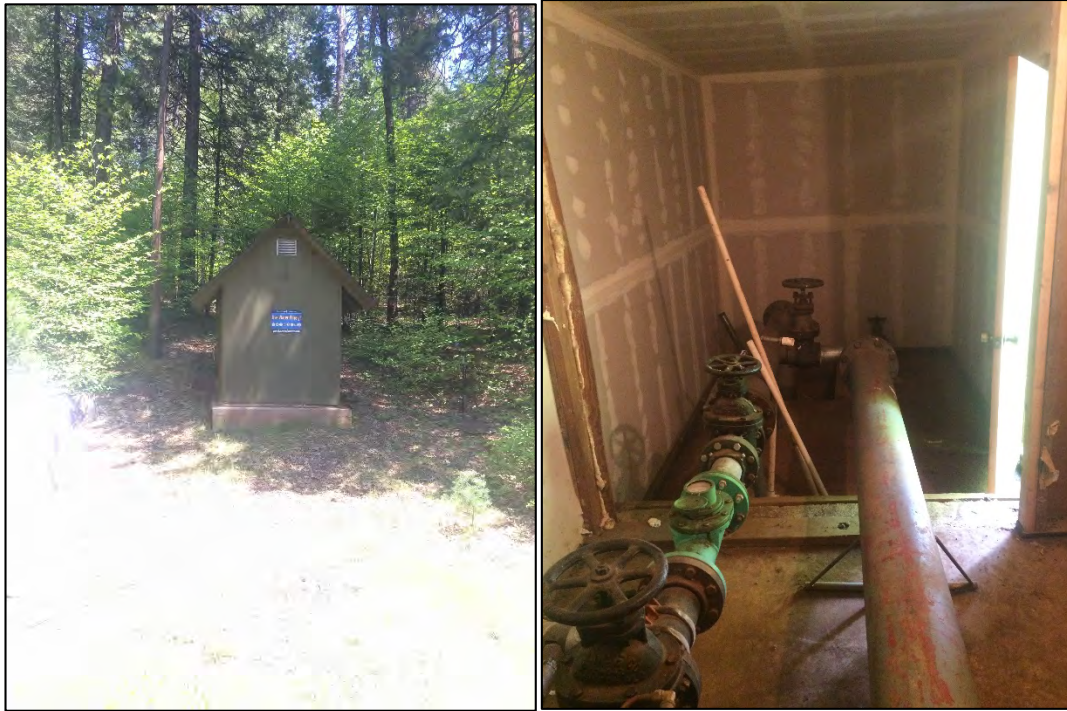
**Figure 3.7a**  
Cypress Point Booster Pump Station

**Figure 3.7a**, below, is a photo of the Cypress Point Booster Station that will require a complete upgrade to provide system reliability. This station, if upgraded, will require new valving, pumps, yard piping, structural improvements, and miscellaneous site improvements.

The Cypress Point Booster Station currently houses an old in-line pump (non-operable). The booster station has old and deteriorated pump house/building, control panel, check valves, piping, and other appurtenances.

The booster pump station upgrade project consists of the installation of two (2) booster pumps (skid mounted), building modifications, electrical and control modification, fencing, paving, and yard piping. The location is noted in **(Figure 6.1)**. A thorough evaluation of the required improvement at the existing booster pump station (Cypress), will be evaluated at the 10% design stage. A preliminary cost-estimate for the upgraded booster pump station is noted in **Section 4**, above. A typical detail for a skid mount booster pump is shown below in **Figure 6.1.5a**. The booster pump station improvement cost are estimated to be \$115,300.
